Rail Accident Report

**Pedestrian struck by a train at Lady Howard
footpath and bridleway crossing, Surrey,
21 April 2022**

Report 01/2023
February 2023

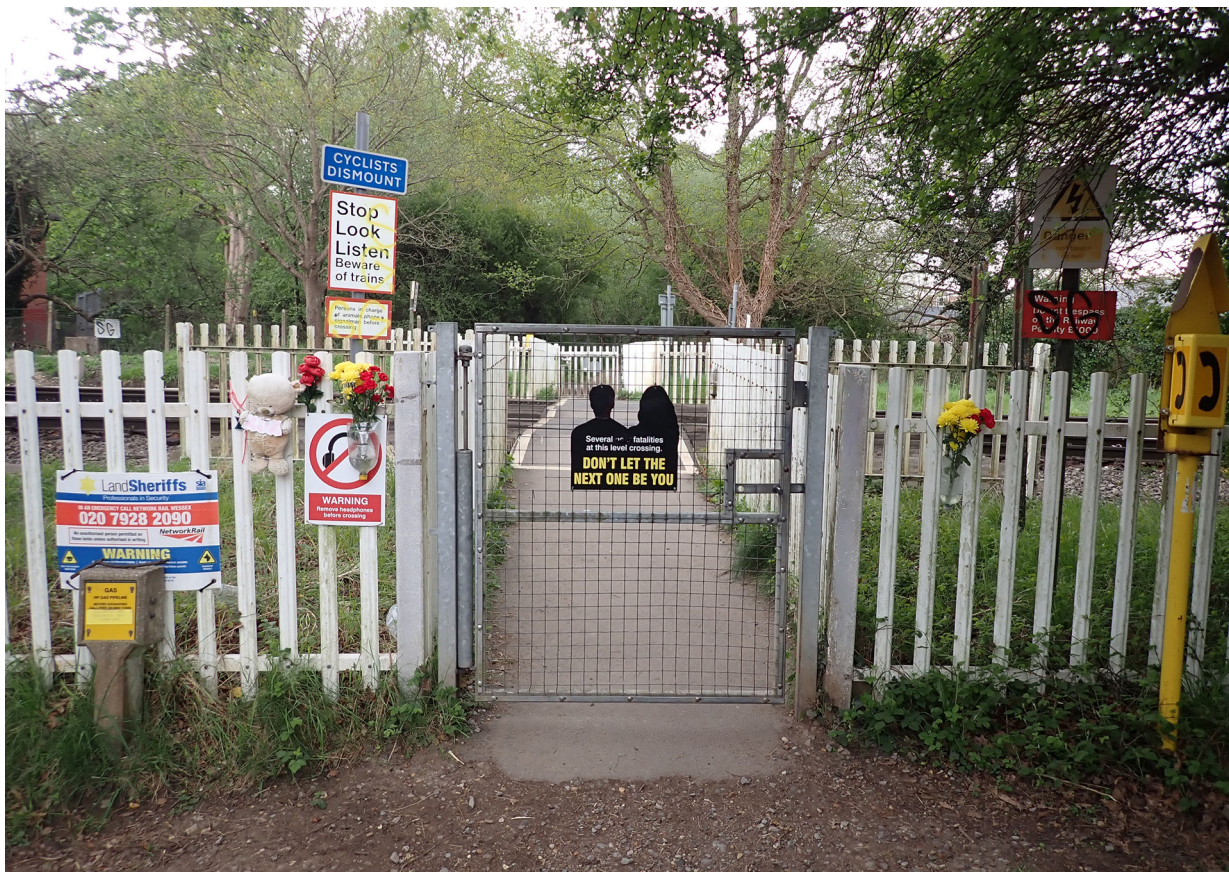
At the time of the accident, some of these signs had been painted with graffiti (figure 3).

Figure 3: The entrance to Lady Howard crossing, approaching from Ashted Common (the direction of the pedestrian at the time of the accident).

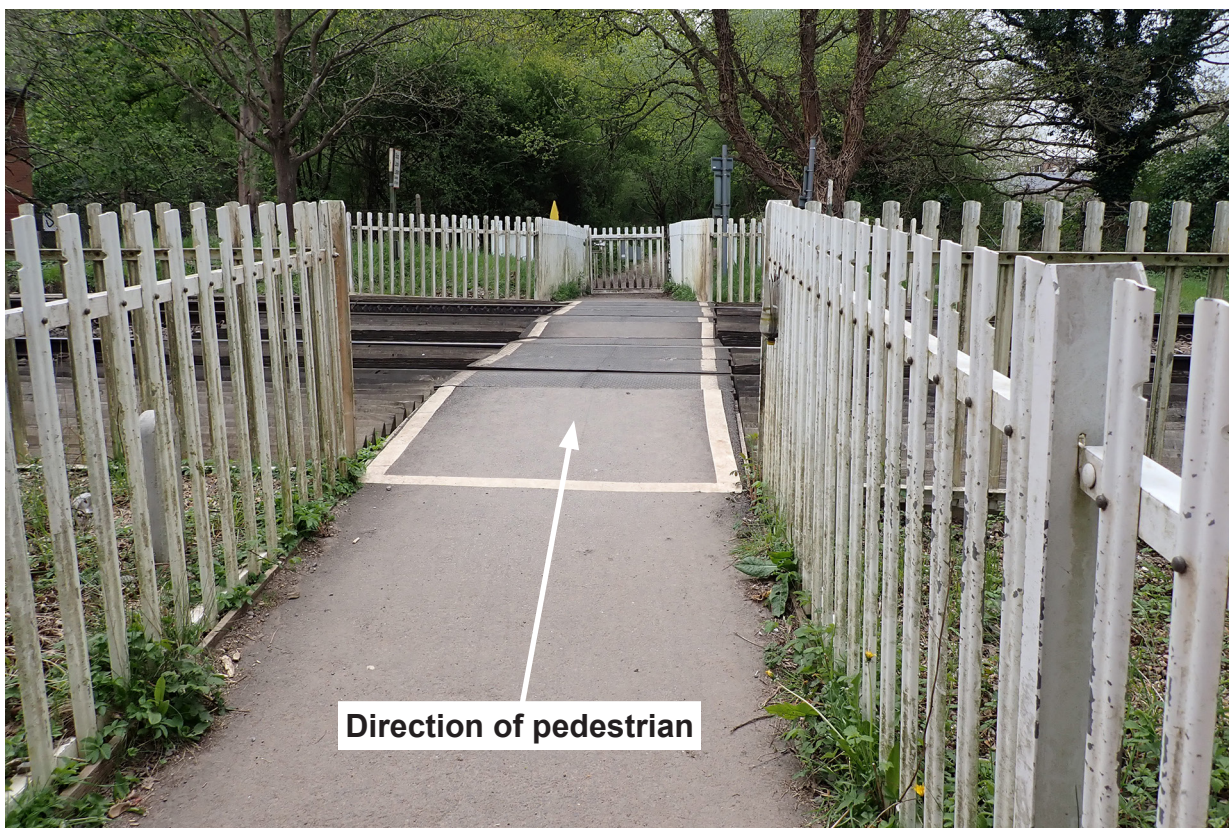
- 15 RAIB measured the fenced corridor inside the gate on the Ashted Common side of the crossing (the approach used by the pedestrian involved in the accident) to be 4.5 metres long. This ends with a white line painted on the asphalt surface 2 metres from the nearest rail of the up Portsmouth line (figure 4). This white line, known as the 'decision point', is the notional point at which users on foot are expected to make a decision as to whether or not it is safe to cross the railway. For crossing users with horses, Network Rail uses a decision point 3 metres from the nearest rail, although this point is not marked on the ground.

Figure 4: Inside the gate at Lady Howard crossing showing the decision point, approaching from Ashted Common.

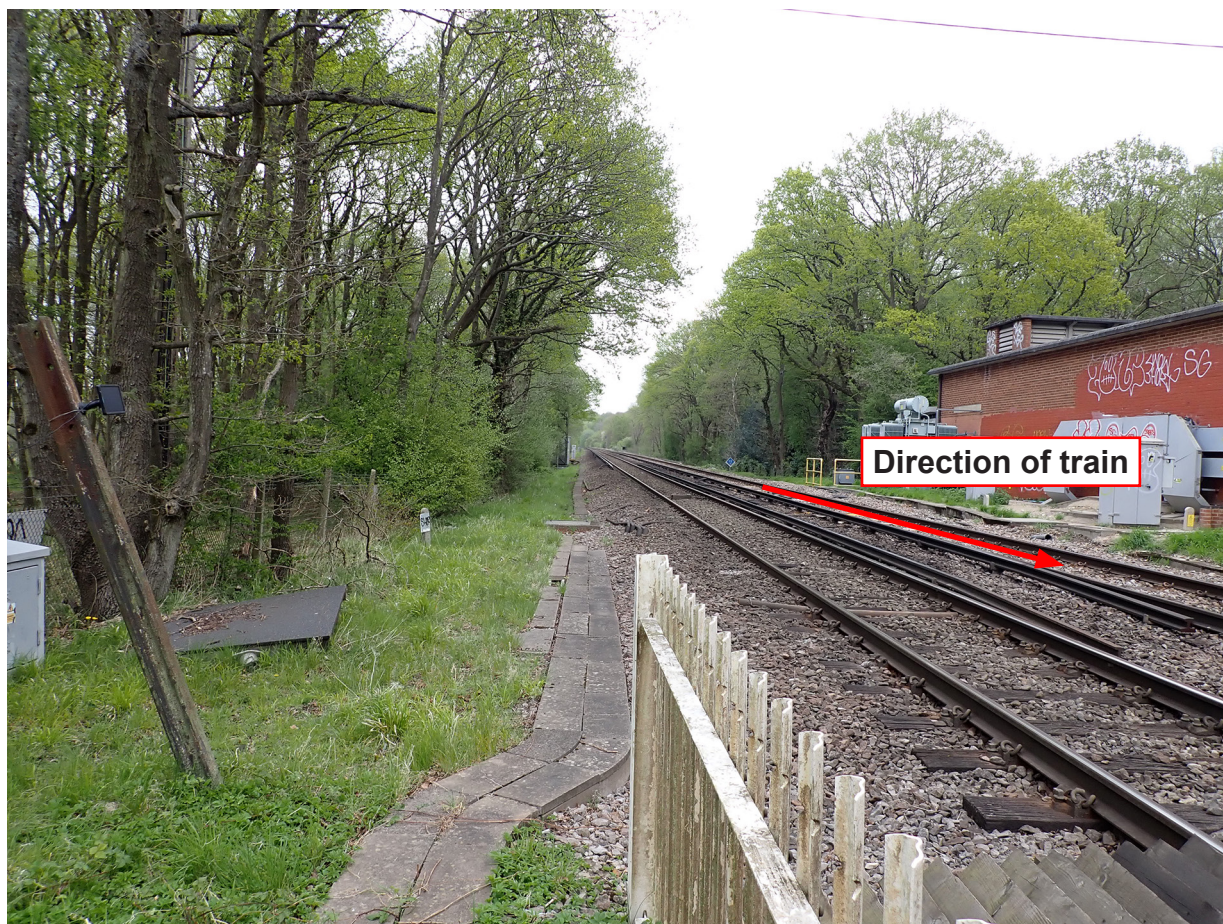
- 16 At the marked decision point, the metal fencing opens out in both directions along the railway. RAIB measured the sighting distances (the distances at which approaching trains can be seen by crossing users) in each direction at this point. On the Ashted Common side, a user standing at the decision point can see for around 440 metres in the direction towards Epsom (the direction from which the train involved in the accident approached). Beyond this point the railway curves to the left from the observer's point of view (figure 5 and figure 6). In the other direction, the railway is straight and users can see for at least 1000 metres to Ashted station.

Figure 5: View from the decision point on the Ashted Common side of Lady Howard crossing, looking towards Epsom.

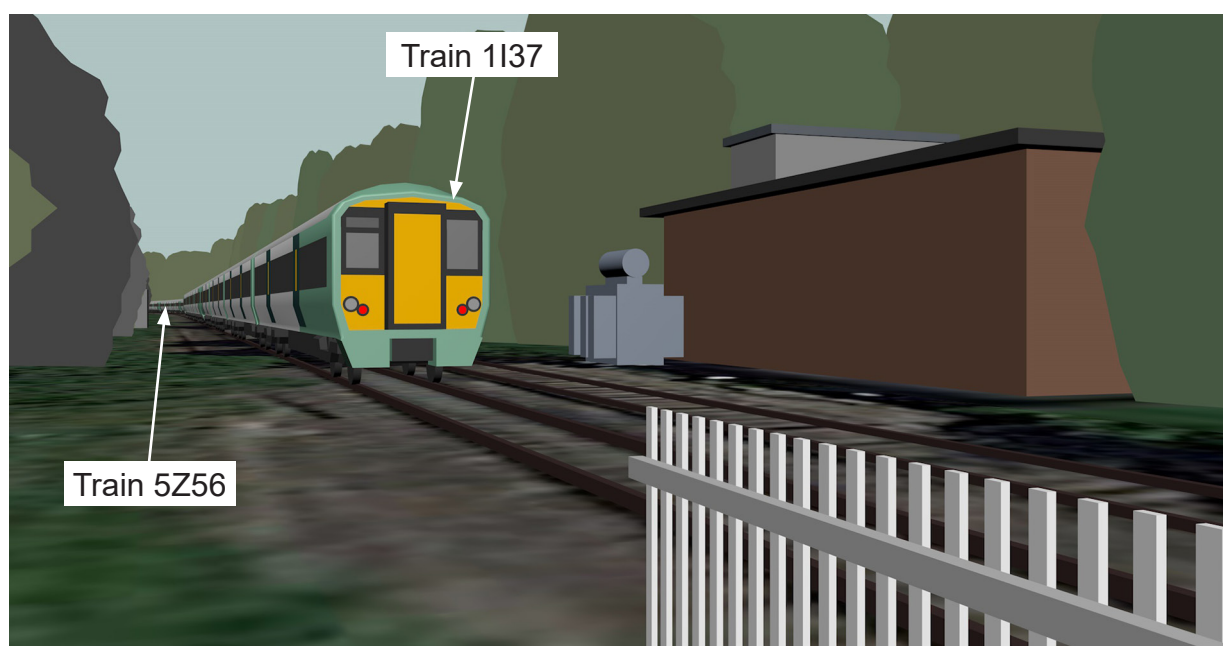
Organisations involved

- 44 RAIB created a computer model of the two trains passing at the crossing, to determine what may or may not have been visible to the pedestrian at the two points when she looked to the left, towards the approaching train 5Z56 (paragraph 35). The model was based on the OTDR evidence from both trains, FFCCTV footage from train 1I37, footage from the CCTV camera at the crossing, and RAIB's survey data for the crossing. Because the OTDR and CCTV data sources are not synchronised, and must be cross-referenced manually, there is a small level of inaccuracy (fractions of seconds) possible with this kind of analysis. However, RAIB has determined that the conclusions which follow reflect the best available evidence.

- 45 When the pedestrian looked twice to the left, the front end of train 5Z56 (which is the most conspicuous part of the train, being painted yellow and displaying headlights) was hidden behind train 1I37, which was receding from the crossing. The front end of train 5Z56 did not re-emerge from behind 1I37 until after the pedestrian had started to cross. Although it may have been possible for the pedestrian to have seen the side of train 5Z56 in the gap beyond train 1I37 and before the railway curved to the left out of view, it would have appeared very small at that distance and not particularly conspicuous (figure 7). This is in part because the green and white painted livery of the train would have provided relatively low contrast against the background of green vegetation.

Figure 7: Computer-generated reconstruction of the view from the pedestrian's perspective looking to her left as she started moving towards the crossing.

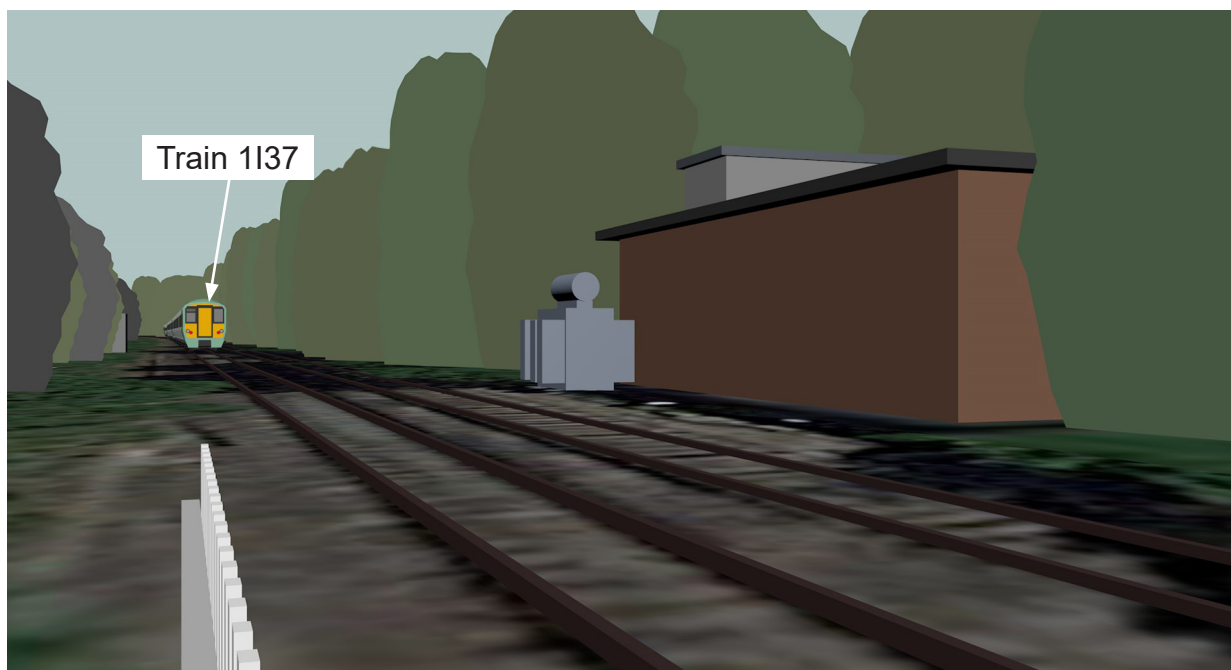
- 50 When the pedestrian took the second glance, as she passed the decision point, RAIB calculated that the rear of train 1137 was around 100 metres beyond the crossing. RAIB has also concluded that, at that point, it is more likely than not that the pedestrian would have been looking towards her left for oncoming trains on the down Portsmouth line to the right of, rather than beyond the front of train 1137 and into the diminishing gap between it and the curve of the railway line.

- 51 Visibility past the trailing end of train 1137 towards the down Portsmouth line would have been greater than 100 metres (figure 8). Given the extent of the visibility available to the pedestrian, it is possible that she decided that this was sufficient distance to be able to safely traverse the crossing, not realising that a train travelling at the maximum permitted speed of 60 mph (97 km/h or 27 m/s) could cover the visible distance in around 4 seconds. At the time of the accident, there were no warnings at the crossing to alert users to this risk.

Figure 8: Computer-generated reconstruction of the view from the pedestrian's perspective looking to her left as she crossed the decision point.
